**PRELIMINARY ASSESSMENT
FOR
DIAZ INTERMEDIATES CORPORATION
AFIN No. 18-00401
WEST MEMPHIS, CRITTENDEN COUNTY, ARKANSAS**

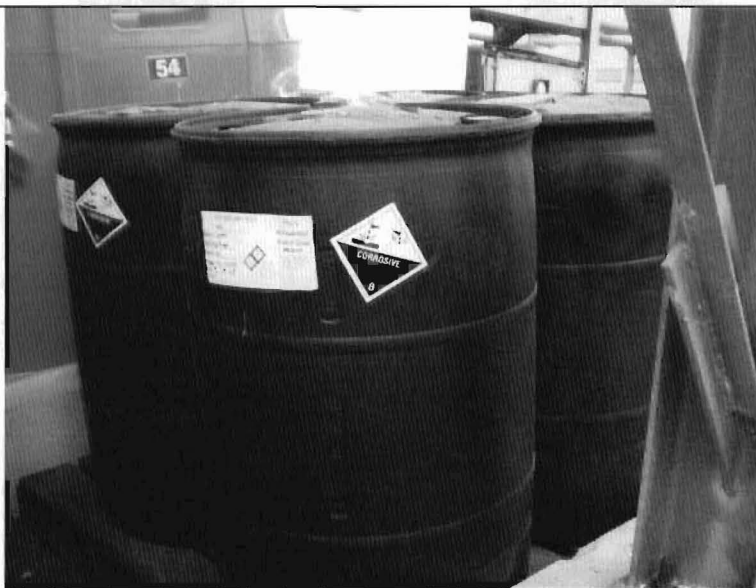
Location:	Diaz Intermediates Corp., 301 Wyanoke Rd., West Memphis, AR 72301						
Photographer:	Les Branscum, ADEQ			Witness:	Penny Wilson, ADEQ		
Photo #	58	Of	67	Date:	28 AUG 07	Time:	1448
Description:	Drum labeled 'Hydrobromic Acid' at south end of Bulk Truck Pad.

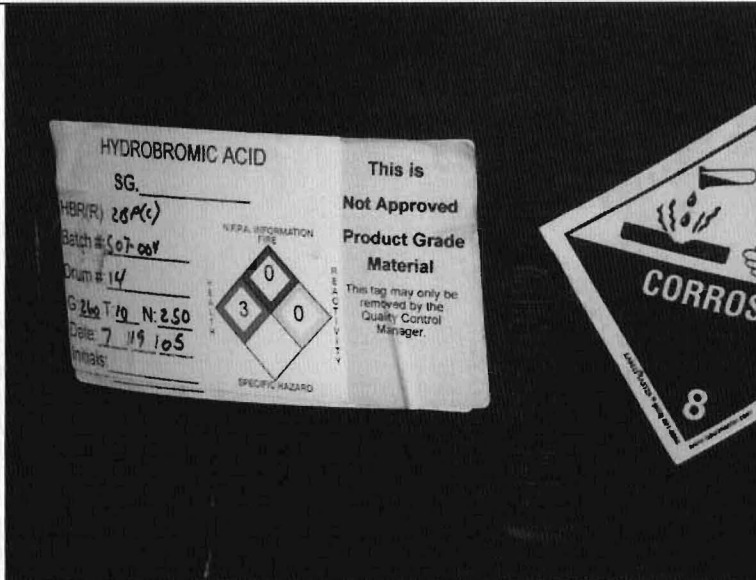
Photographer:	Les Branscum, ADEQ			Witness:	Penny Wilson, ADEQ		
Photo #	59	Of	67	Date:	28 AUG 07	Time:	1448
Description:	Close up of drum in photo 58 showing date of 7-19-05.

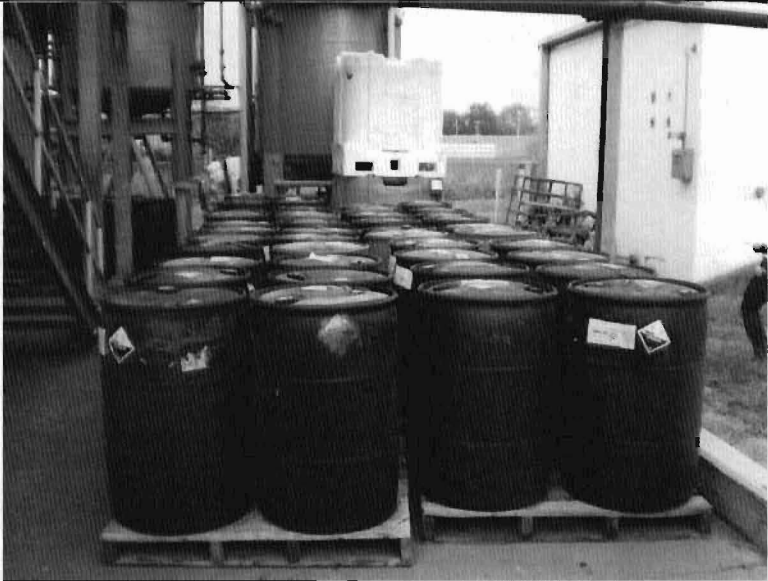
Location:		Diaz Intermediates Corp., 301 Wyanoke Rd., West Memphis, AR 72301						
Photographer:		Les Branscum, ADEQ			Witness:		Penny Wilson, ADEQ	
Photo #	60	Of	67		Date:	28 AUG 07	Time:	1451
Description:		View of South Pad south of Process Building, facing east.

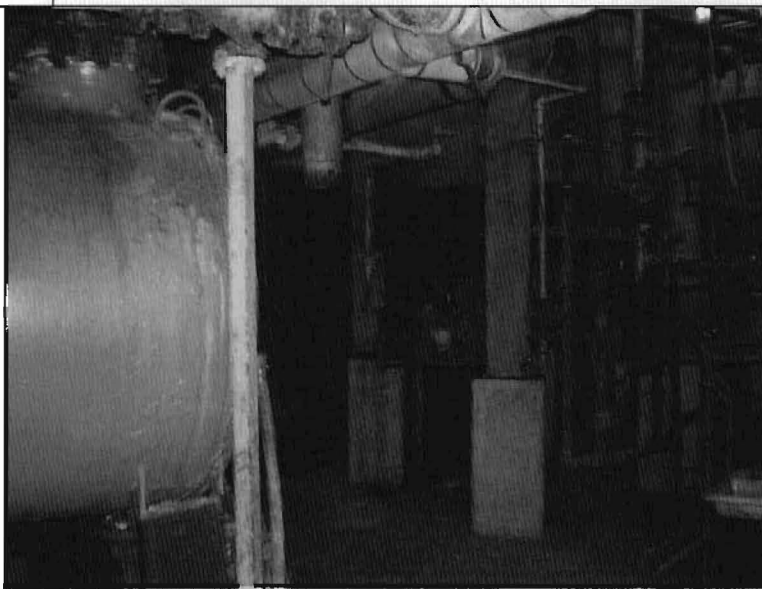
Location:	Diaz Intermediates Corp., 301 Wyanoke Rd., West Memphis, AR 72301							
Photographer:	Les Branscum, ADEQ			Witness:	Penny Wilson, ADEQ			
Photo #	62	Of	67		Date:	28 AUG 07	Time:	1456
Description:		View to the left of photo 61 inside Process Building.

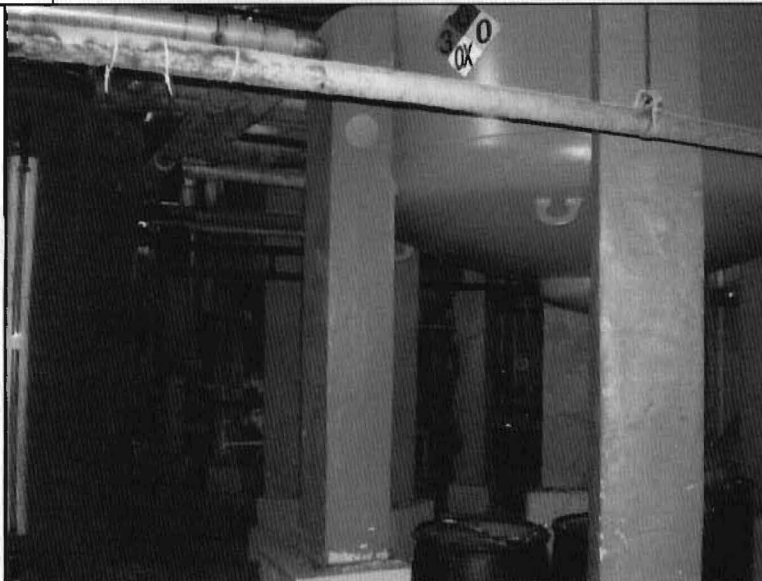
Photographer:	Les Branscum, ADEQ			Witness:	Penny Wilson, ADEQ			
Photo #	63	Of	67		Date:	28 AUG 07	Time:	1500
Description:		Facing south inside Process Building, west side. Tank in foreground has approx. 7600 kilos of Liquid Bromine since Jan 07.

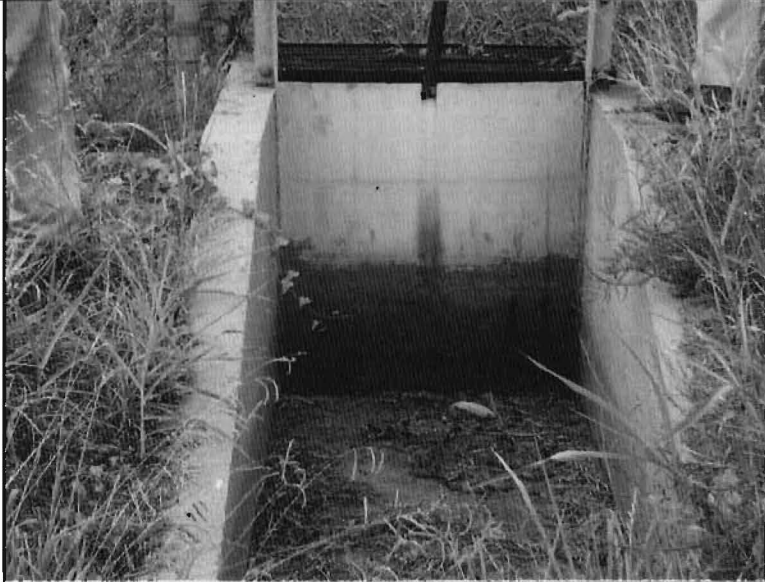
Location:	Diaz Intermediates Corp., 301 Wyanoke Rd., West Memphis, AR 72301						
Photographer:	Les Branscum, ADEQ				Witness:	Penny Wilson, ADEQ	
Photo #	66	Of	67		Date:	28 AUG 07	Time: 1537
Description:	Storm drain gate almost closed but had to be hammered the last inch.

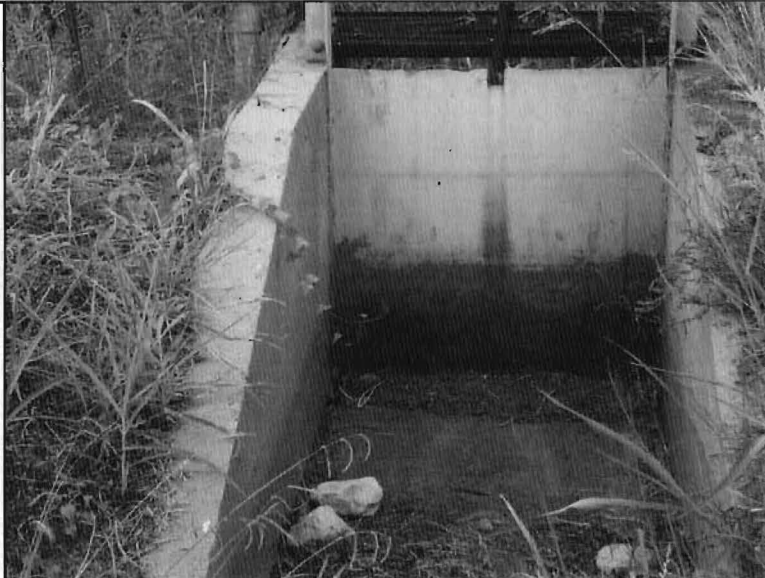
Photographer:	Les Branscum, ADEQ				Witness:	Penny Wilson, ADEQ	
Photo #	67	Of	67		Date:	28 AUG 07	Time: 1550
Description:	Storm drain fully closed with dirt pushed against it to help seal.

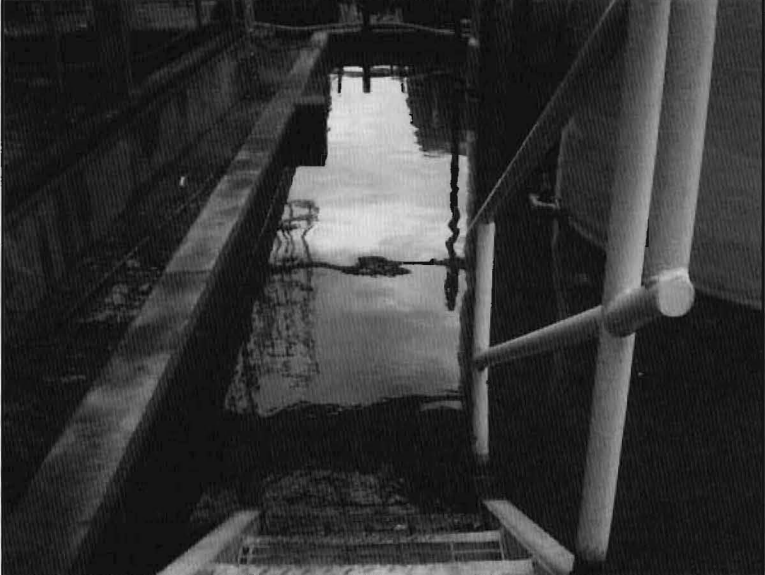
Photographer:		Les Branscum, ADEQ				Witness:		N/A	
Photo #	2	Of	5			Date:	24 OCT 07	Time:	1319
Description:		Second or 'new' tank containment area at Diaz. Water level from rain is quite high. The 'old' tank containment is to the left in the photo.

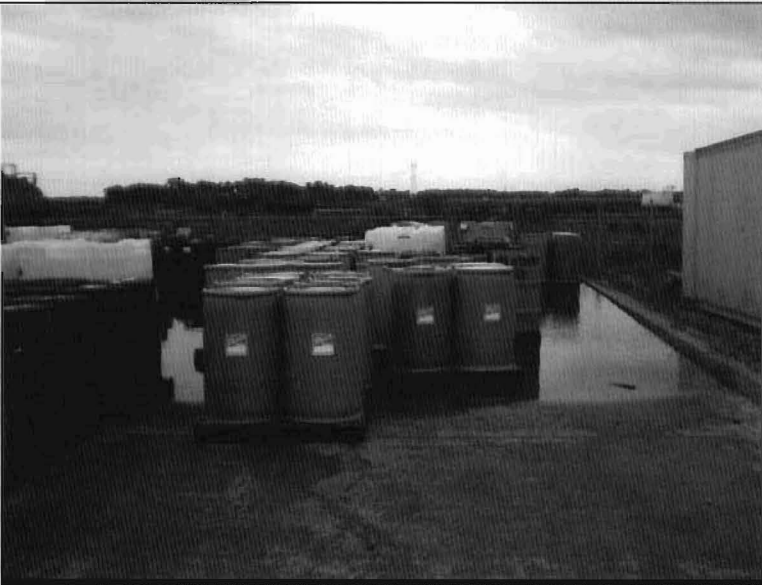
Location:	Diaz Intermediates, 301 Wyanoke Rd, West Memphis, AR						
Photographer:	Les Branscum, ADEQ				Witness:	N/A	
Photo #	3	Of	5		Date:	24 OCT 07	Time: 1321
Description:	View of north drum pad showing standing water in containment.

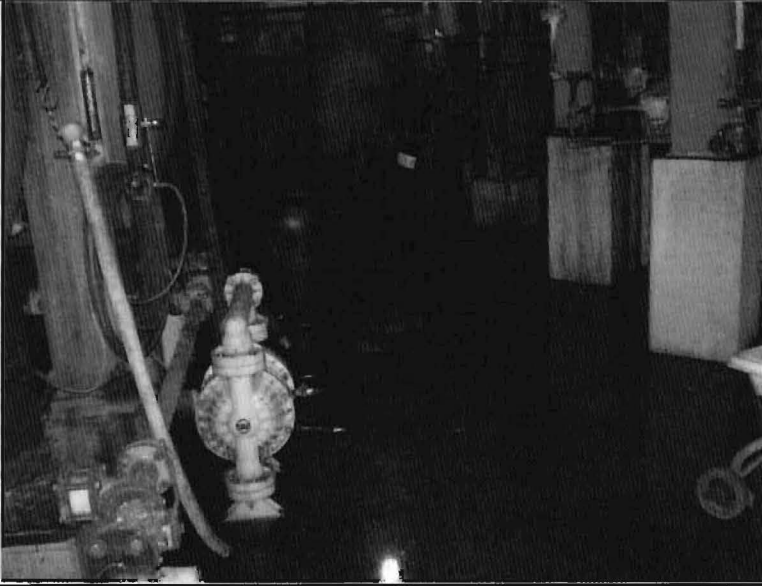
Location:	Diaz Intermediates, 301 Wyanoke Rd., West Memphis, AR						
Photographer:	Les Branscum, ADEQ			Witness:	N/A		
Photo #	5	Of	5	Date:	24 OCT 07	Time:	1326
Description:	View inside the first floor of the Diaz production building showing flooded floor.

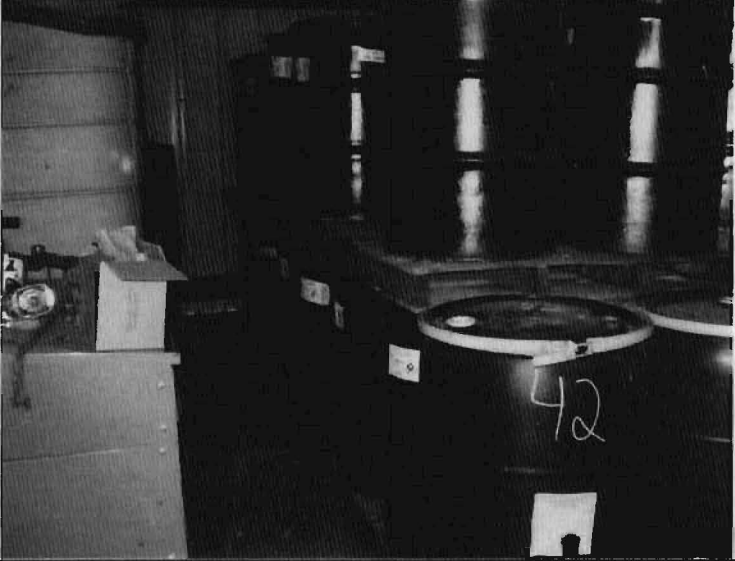
Photographer:		Les Branscum, ADEQ <i>LB</i>				Witness:		none	
Photo #	2	Of	35		Date:	29 NOV 07	Time:	1226	
Description:		55 gallon metal drum at back of bottom row in photo 1. Crystalline substance appears to have come from a leak in the drum.

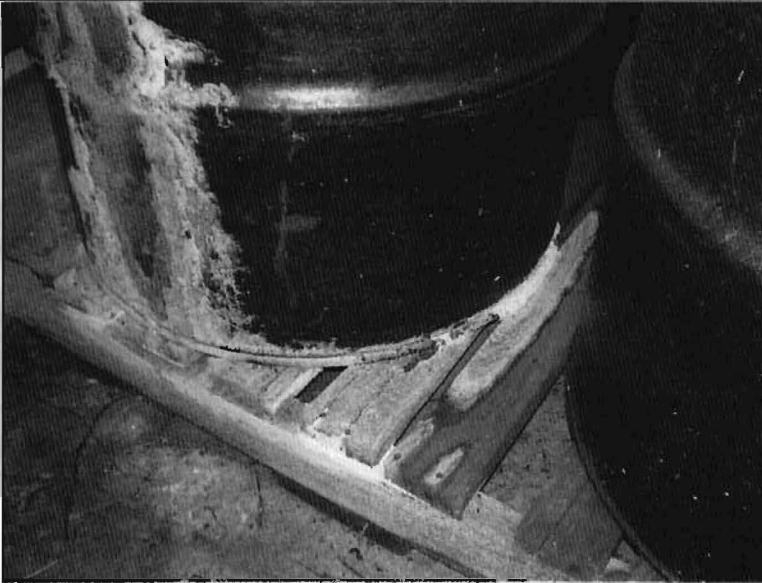
Location:		Diaz Intermediates					
Photographer:		Les Branscum, ADEQ			Witness:		none
Photo #	3	Of	35		Date:	29 NOV 07	Time: 1228
Description:		Close up of crystal substance on drum and pallet in photo 2. Note that concrete floor is dry.

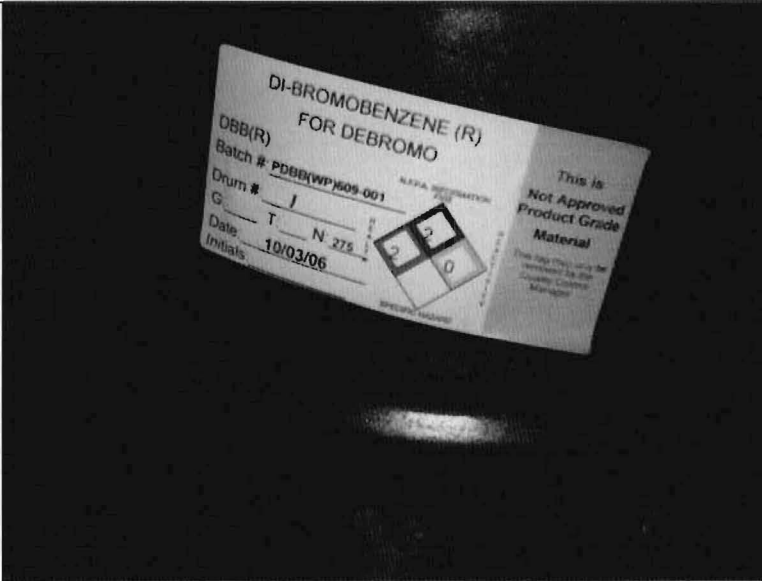
Photographer:		Les Branscum, ADEQ			Witness:		none
Photo #	4	Of	35		Date:	29 NOV 07	Time: 1231
Description:		Label on drum in photos 2 & 3. All drums in this row that were leaking had this label and date of 10-03-06.

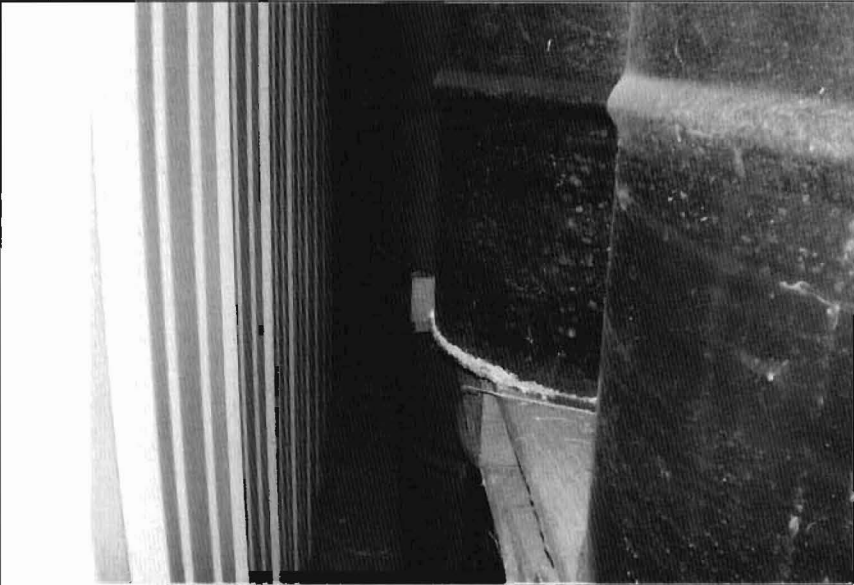
Location:	Diaz Intermediates						
Photographer:	Les Branscum, ADEQ				Witness:	none	
Photo #	5	Of	35		Date:	29 NOV 07	Time: 1233
Description:	Drum on inside row and above one in photos 2 & 3. Bottoms of most drums in these 2 rows had some deterioration.

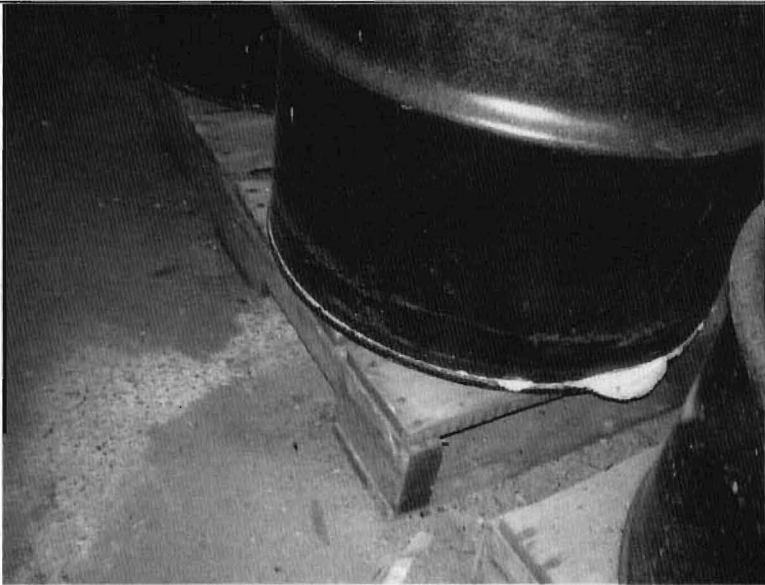
Location:	Diaz Intermediates						
Photographer:	Les Branscum, ADEQ				Witness:	none	
Photo #	7	Of	35		Date:	29 NOV 07	Time: 1238
Description:	View of 3 rd drum forward from one in photo 2. Note concrete appears to have been eaten by earlier leak(s).

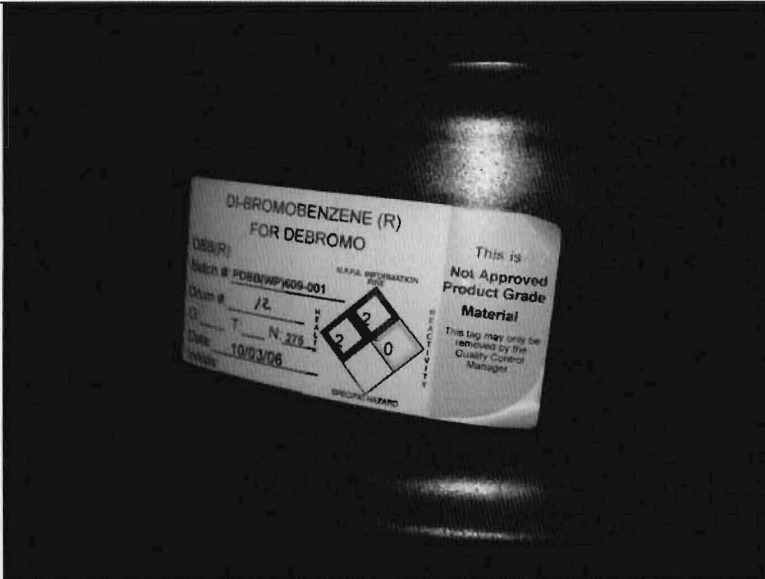
Photographer:	Les Branscum, ADEQ				Witness:	none	
Photo #	8	Of	35		Date:	29 NOV 07	Time: 1240
Description:	Label on drum in photo 7.

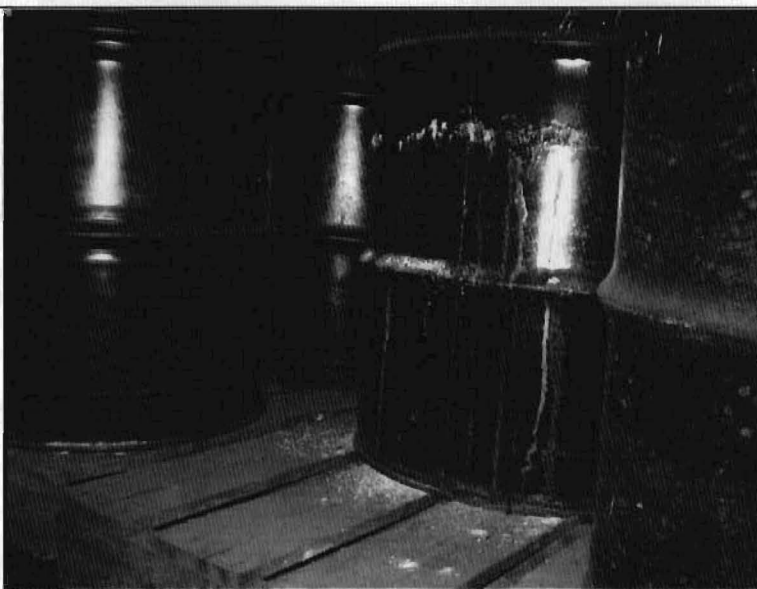
Location:	Diaz Intermediates							
Photographer:	Les Branscum, ADEQ				Witness:	none		
Photo #	9	Of	35		Date:	29 NOV 07	Time:	1242
Description:	Drum on top row above one in photo 8. Contents appear to have eaten through the drum and residue fallen on the pallet.

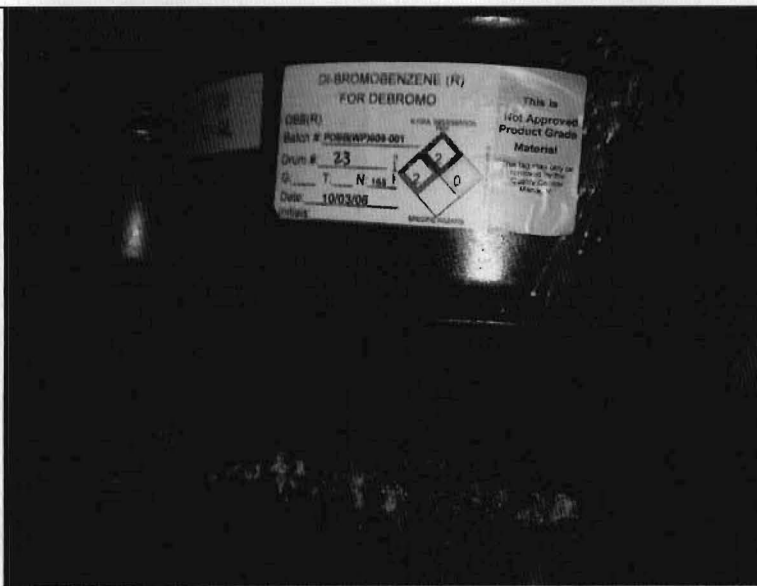
Photographer:	Les Branscum, ADEQ				Witness:	none		
Photo #	10	Of	35		Date:	29 NOV 07	Time:	1244
Description:	Label on drum in photo 9.

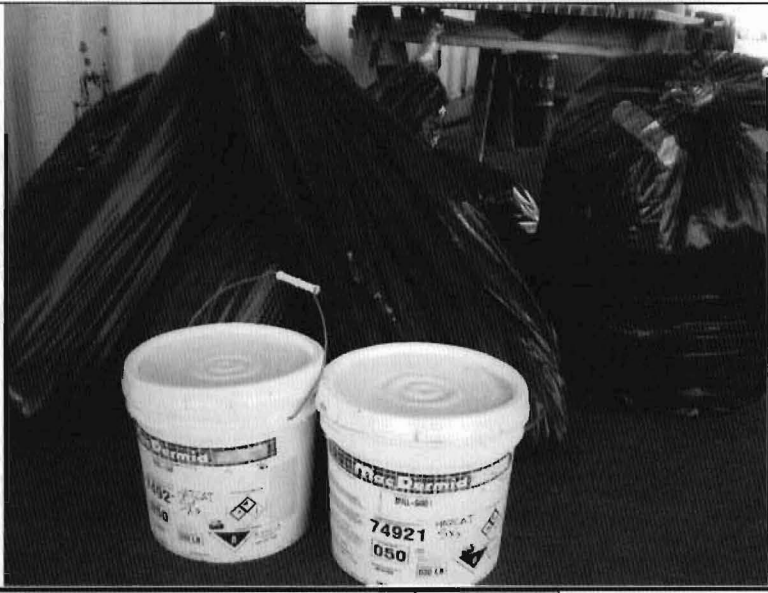
Location:	Diaz Intermediates						
Photographer:	Les Branscum, ADEQ				Witness:	none	
Photo #	13	Of	35		Date:	29 NOV 07	Time: 1254
Description:	View of residue left after the EPA Hazcat event. This is located on the loading ramp just outside the warehouse.

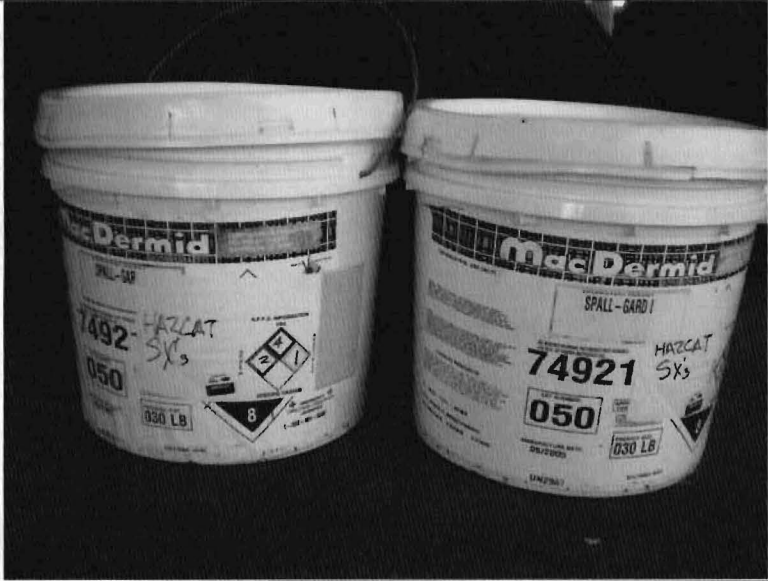
Photographer:	Les Branscum, ADEQ				Witness:	none	
Photo #	14	Of	35		Date:	29 NOV 07	Time: 1255
Description:	Close up of the pails in photo 13.

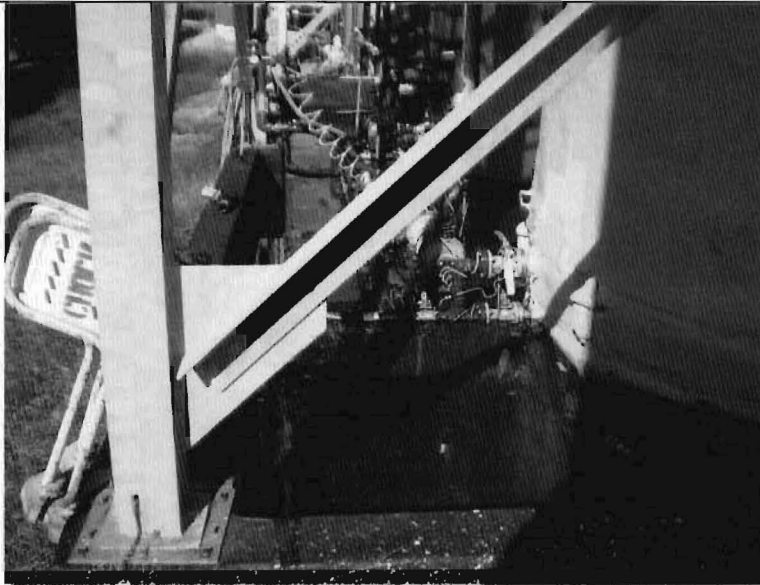
Photographer:	Les Branscum, ADEQ				Witness:	none		
Photo #	18	Of	35		Date:	29 NOV 07	Time:	1312
Description:		Containment in the uncovered tank farm. Water is at a much higher level from rain events.

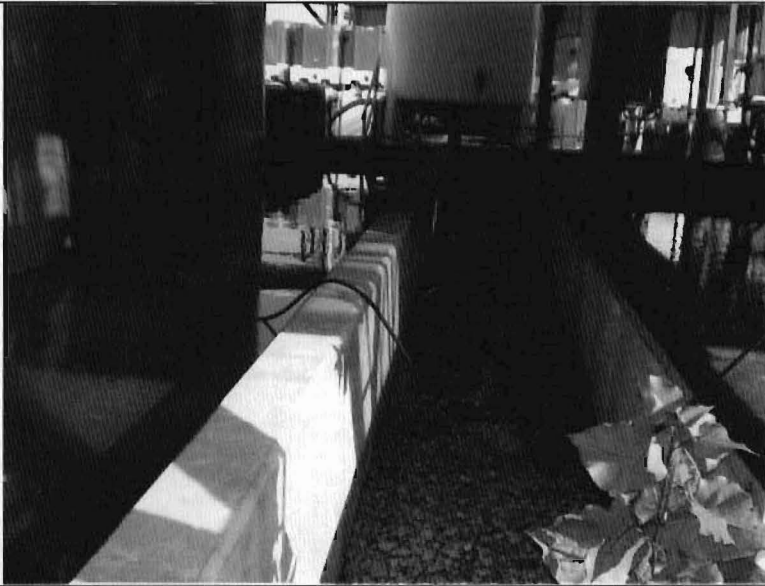
Location:		Diaz Intermediates					
Photographer:		Les Branscum, ADEQ			Witness:		none
Photo #	19	Of	35		Date:	29 NOV 07	Time: 1312
Description:		View of both containment areas in covered and uncovered tank farms. Uncovered containment is to the left.

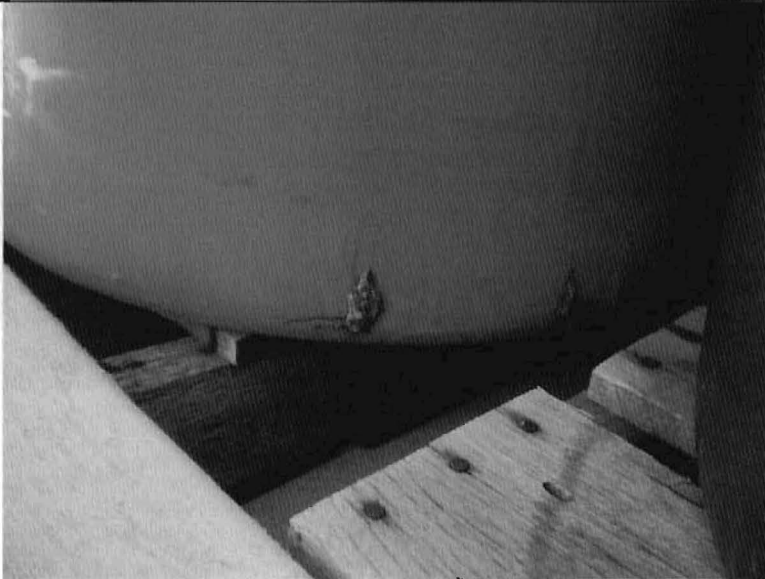
Photographer:		Les Branscum, ADEQ			Witness:		none
Photo #	20	Of	35		Date:	29 NOV 07	Time: 1316
Description:		Blue drum on 5 th row from the uncovered tank containment. Other drums on pad may be in similar condition but may not be visible due to tight rows of drums.

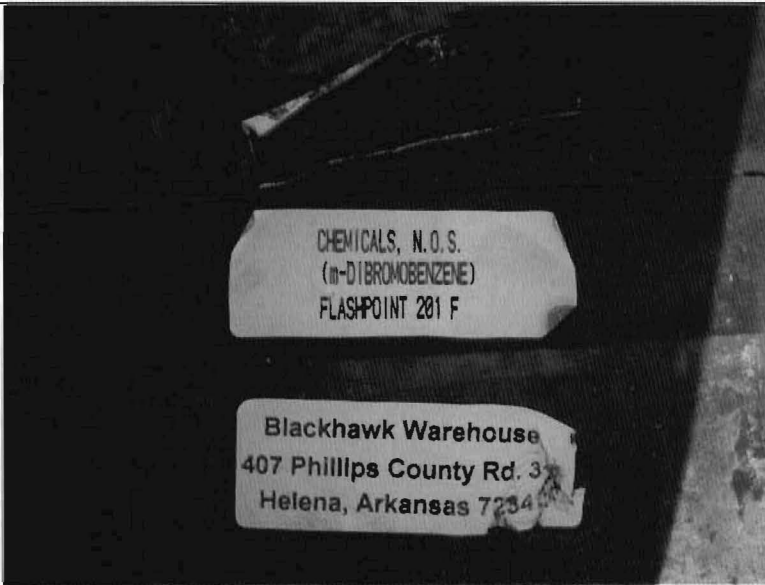
Location:	Diaz Intermediates						
Photographer:	Les Branscum, ADEQ				Witness:	none	
Photo #	21	Of	35		Date:	29 NOV 07	Time: 1316
Description:	Label on top of drum in photo 20.

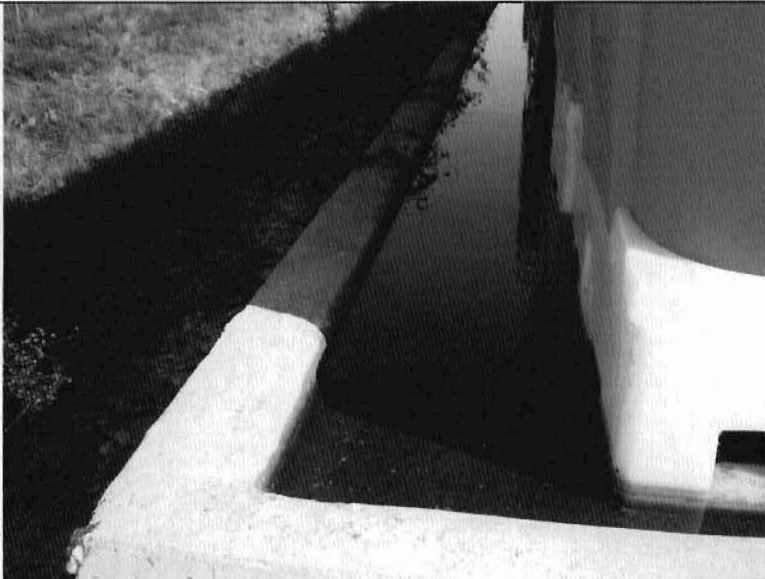
Photographer:	Les Branscum, ADEQ				Witness:	none	
Photo #	22	Of	35		Date:	29 NOV 07	Time: 1320
Description:	Standing water at back of drum pad containment. The pad is sloped; less than half of the pad had water.

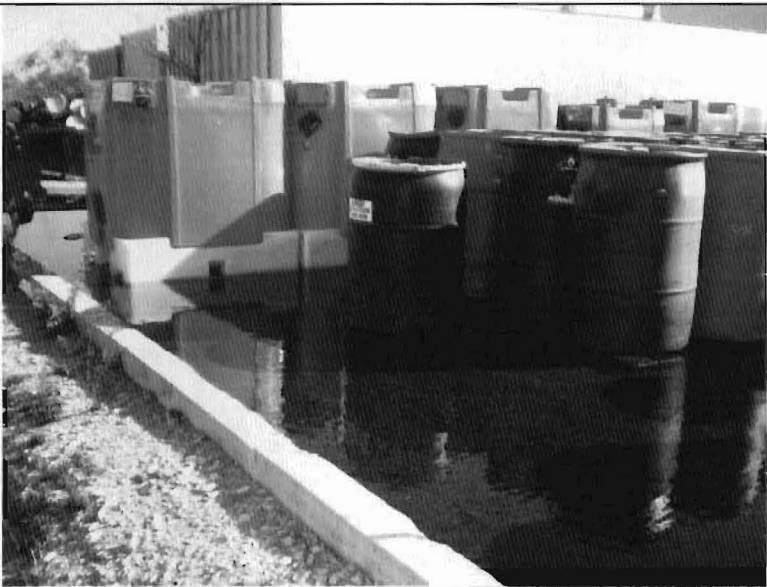
Photographer:		Les Branscum, ADEQ			Witness:		none
Photo #	24	Of	35		Date:	29 NOV 07	Time: 1325
Description:		Corner of drum pad in far left of photo 23. Note where water has leaked over containment. Drainage ditch can be seen at right.

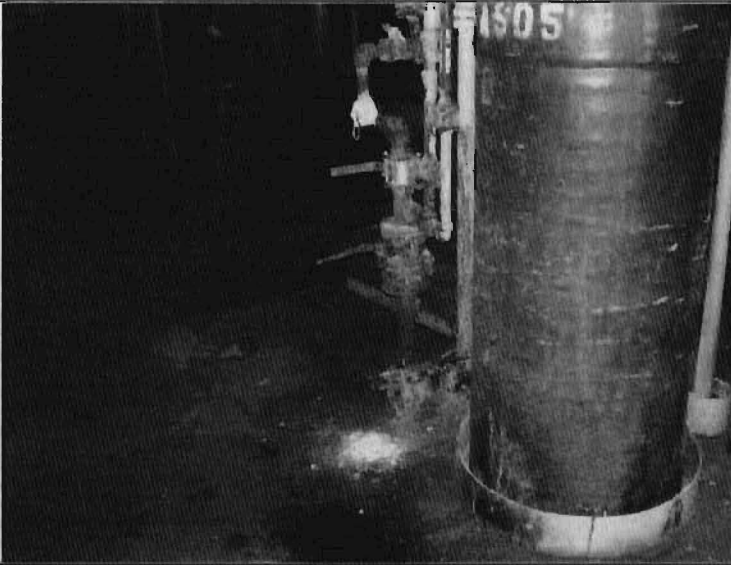
Photographer:		Les Branscum, ADEQ <i>LB</i>			Witness:		none
Photo #	32	Of	35		Date:	29 NOV 07	Time: 1420
Description:		Close up of the rusted and corroded valve in photo 31.

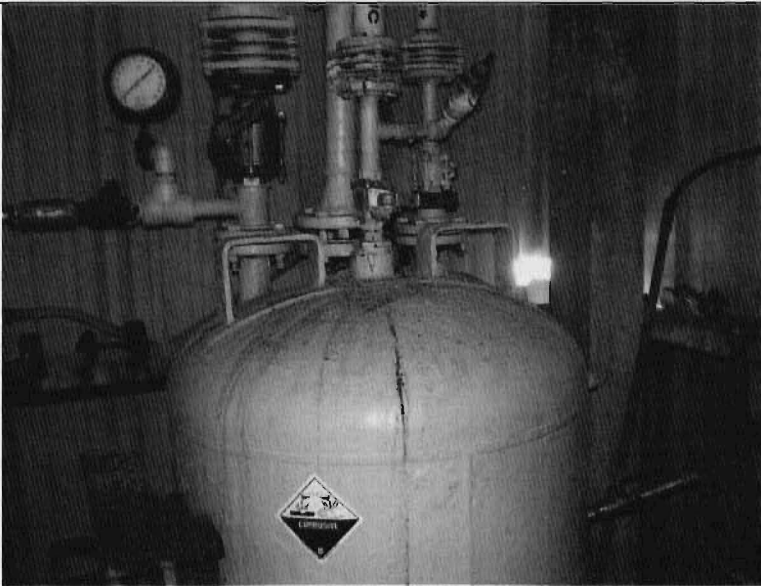
Photographer:	Les Branscum, ADEQ				Witness:	none	
Photo #	34	Of	35		Date:	29 NOV 07	Time: 1423
Description:	Close up of piping system on tank in photo 33 showing corrosion on pipe system.

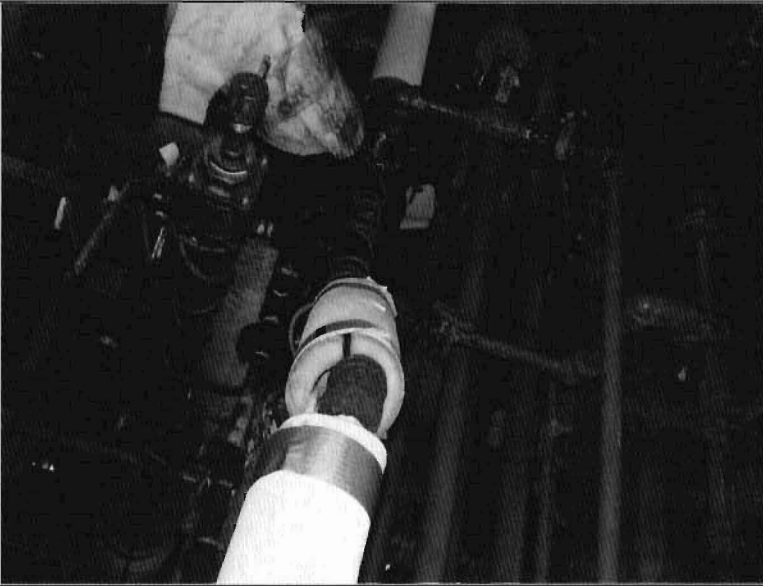
Location:		Diaz Intermediates							
Photographer:		Les Branscum, ADEQ				Witness:		none	
Photo #	35	Of	35			Date:	29 NOV 07	Time:	1430
Description:		Some of the overhead pipes on the 2 nd floor of the Production Building showing extensive rust.

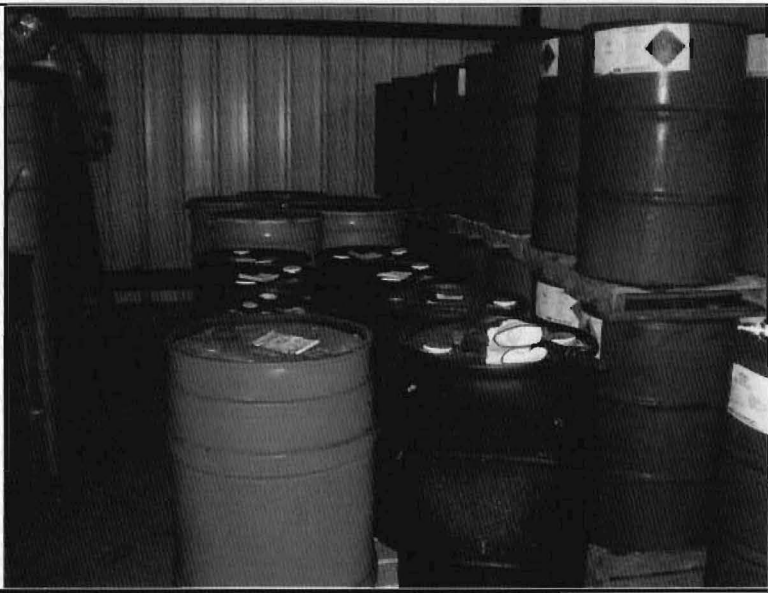
Location:		Diaz Intermediates, West Memphis, AR							
Photographer:		Les Branscum, ADEQ			Witness:		Charles Fisher, EPA		
Photo #	1	Of	16			Date:	29 JAN 08	Time:	1157
Description:		View of the left side of the warehouse as you enter from the loading dock. All leaking drums have been over-packed. Poly drums in foreground are from the north wall of the warehouse. They are Hydrobromic Acid x 4 and 1 each M-Bromoflorobenzene, N-Heptylbromide, 2-3 Dibromobutane and 1-2 Bromopyridine.

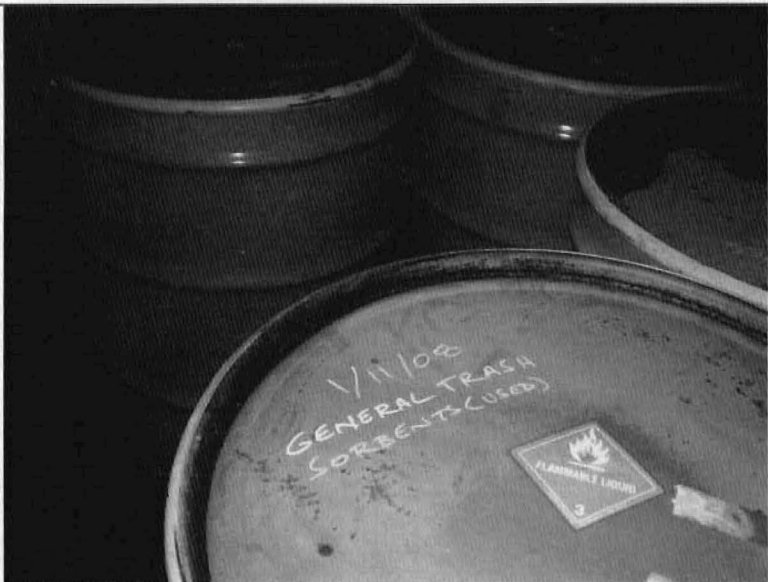
Photographer:		Les Branscum, ADEQ			Witness:		Charles Fisher, EPA		
Photo #	2	Of	16			Date:	29 JAN 08	Time:	1200
Description:		Over-pack drums in back of row in photo 1. These contain PPE, sorbents and 'hot trash' from the EPA hazcat done in OCT 07.

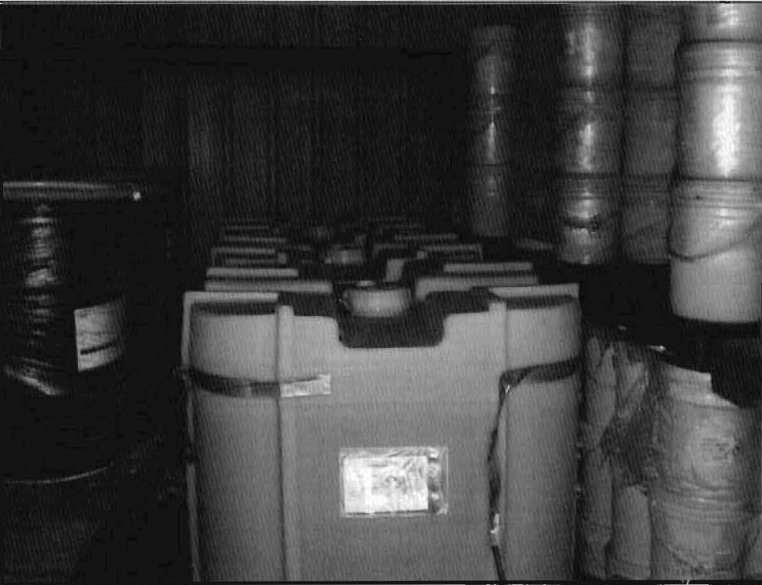
Location:		Diaz Intermediates, West Memphis, AR						
Photographer:		Les Branscum, ADEQ			Witness:		Charles Fisher, EPA	
Photo #	3	Of	16		Date:	29 JAN 08	Time:	1210
Description:		Three totes that the pumpable contents of the leaking metal drums were pumped into.

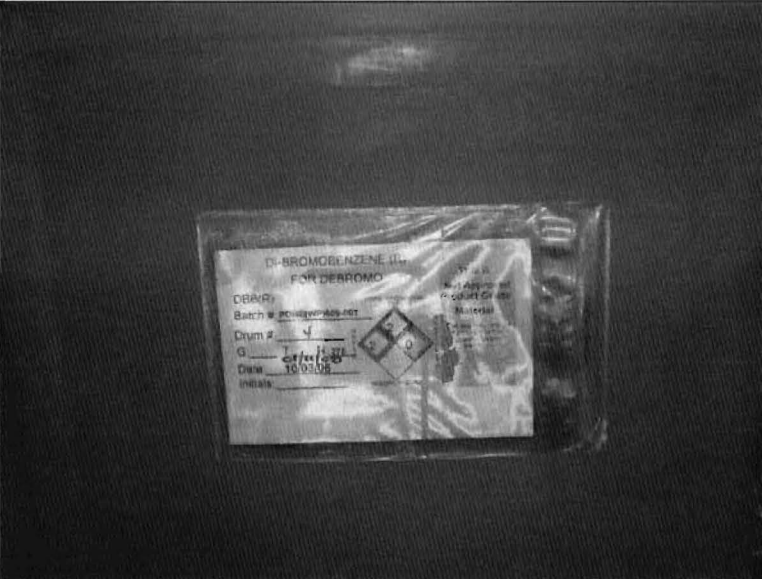
Photographer:		Les Branscum, ADEQ			Witness:		Charles Fisher, EPA	
Photo #	4	Of	16		Date:	29 JAN 08	Time:	1210
Description:		Close up of label (which came from leaking drum) on the nearest tote in photo 3. Date of 01-11-08 was written in when the tote was filled.

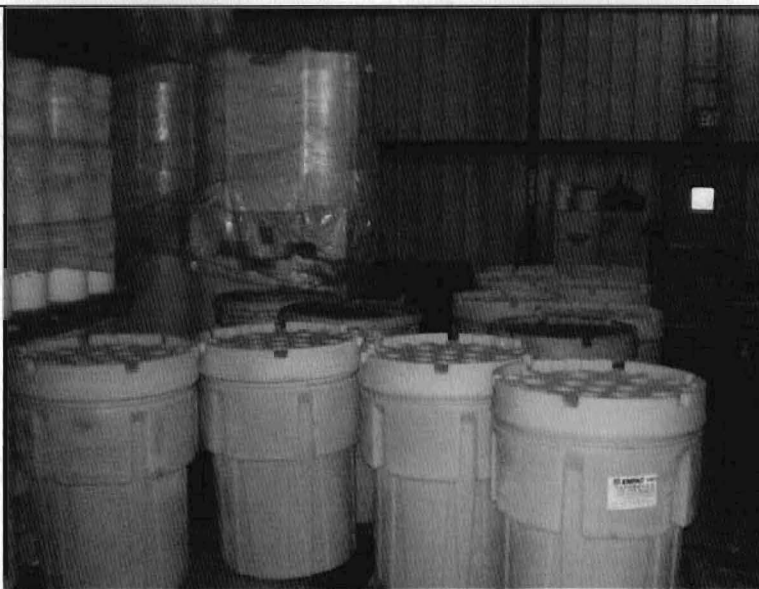
Photographer:	Les Branscum, ADEQ			Witness:	Charles Fisher, EPA		
Photo #	6	Of	16	Date:	29 JAN 08	Time:	1213
Description:	Rusted metal drums discovered during the over-pack process that were not leaking but were badly rusted. EPA contractors placed them on pallets and plastic and encircled them with granular sorbent.

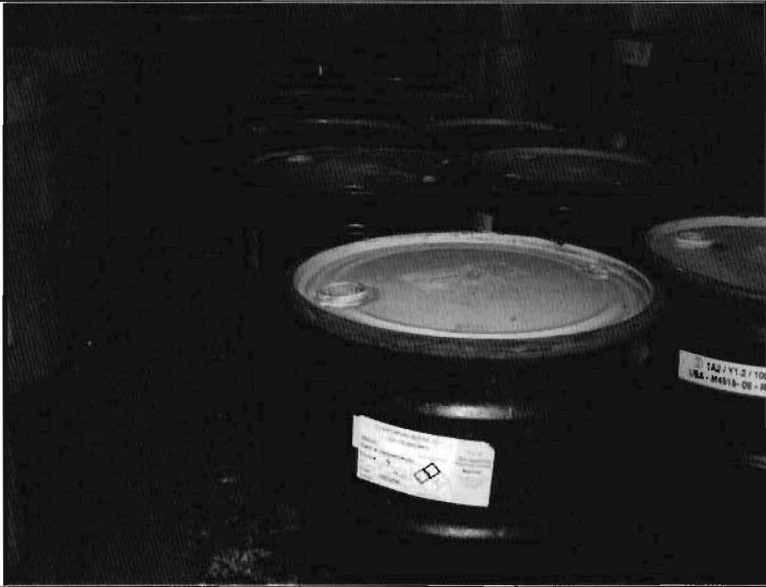
Location:	Diaz Intermediates, West Memphis, AR						
Photographer:	Les Branscum, ADEQ				Witness:	Charles Fisher, EPA	
Photo #	7	Of	16		Date:	29 JAN 08	Time: 1213
Description:	Close up of drums in photo 6 showing rusted condition.

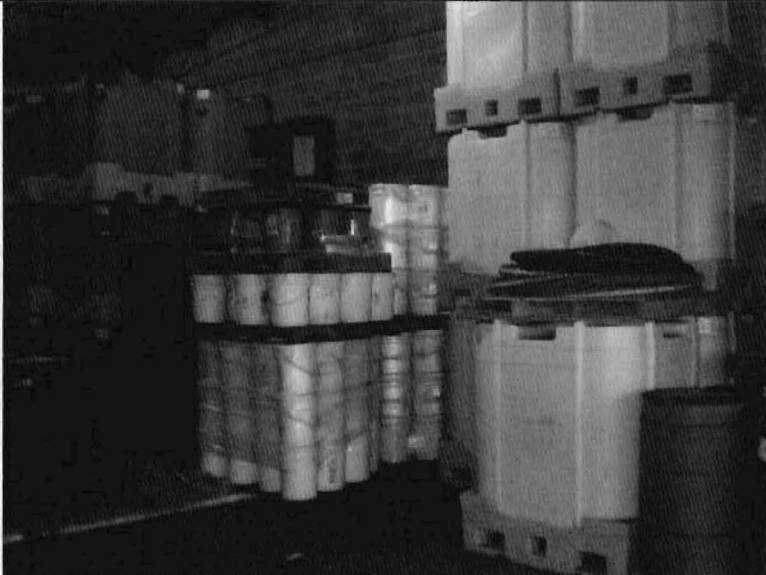
Photographer:	Les Branscum, ADEQ				Witness:	Charles Fisher, EPA	
Photo #	8	Of	16		Date:	29 JAN 08	Time: 1215
Description:	North wall of warehouse showing the rearranging done by EPA. Fork lifts were placed outside.

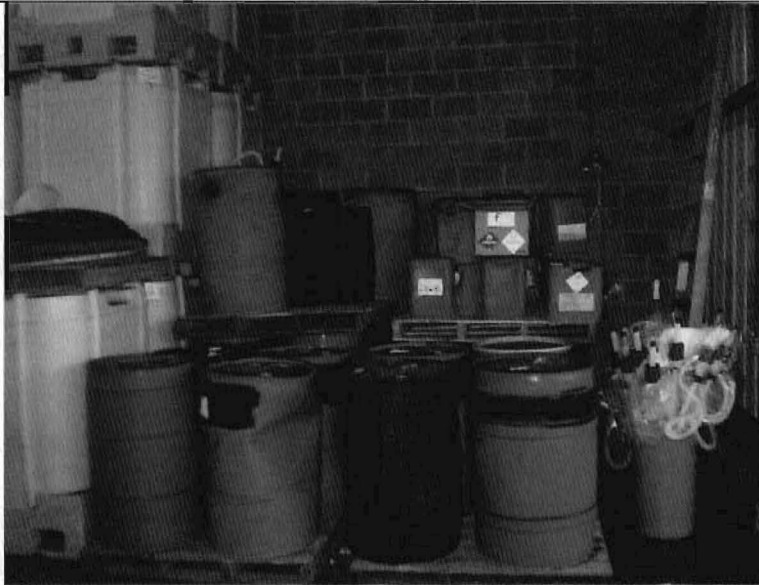
Location:	Diaz Intermediates, West Memphis, AR						
Photographer:	Les Branscum, ADEQ			Witness:	Charles Fisher, EPA		
Photo #	9	Of	16		Date:	29 JAN 08	Time: 1215
Description:	Another view of containers on the north side of the warehouse. Poly drums in photo 1 were on top of the poly drums in the foreground.

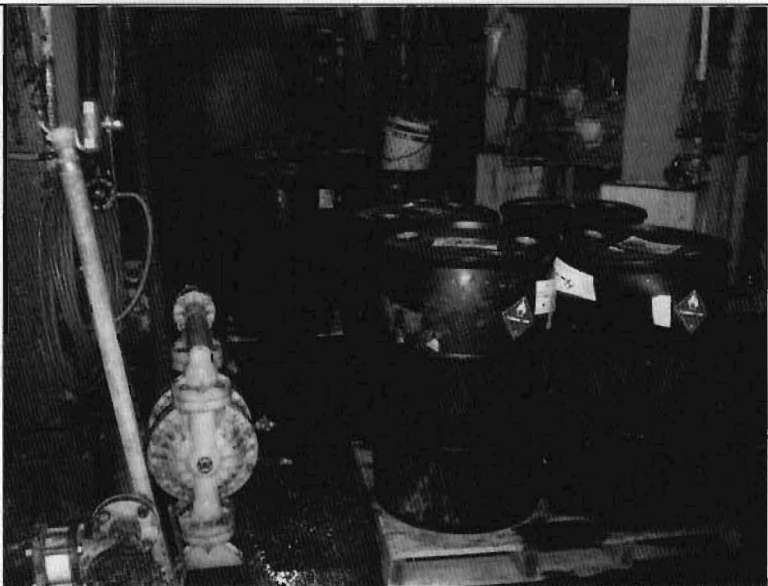
Location:		Diaz Intermediates, West Memphis, AR						
Photographer:		Les Branscum, ADEQ			Witness:		Charles Fisher, EPA	
Photo #	11	Of	16		Date:	29 JAN 08	Time:	1227
Description:		First floor of Production Building showing drums that were on the floor now on pallets.

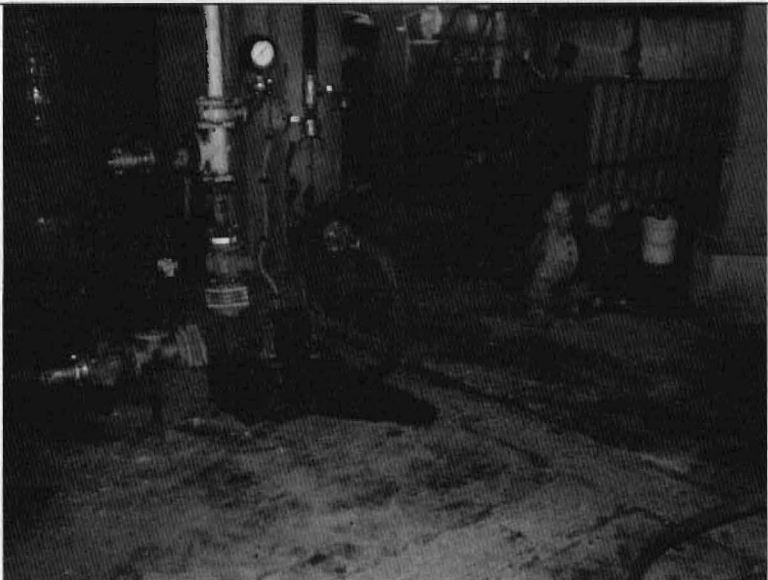
Photographer:		Les Branscum, ADEQ			Witness:		Charles Fisher, EPA	
Photo #	12	Of	16		Date:	29 JAN 08	Time:	1230
Description:		Area in back of first floor of the containment building where water had been standing for months. Water was removed and placed in the covered tank containment, (old tank farm).

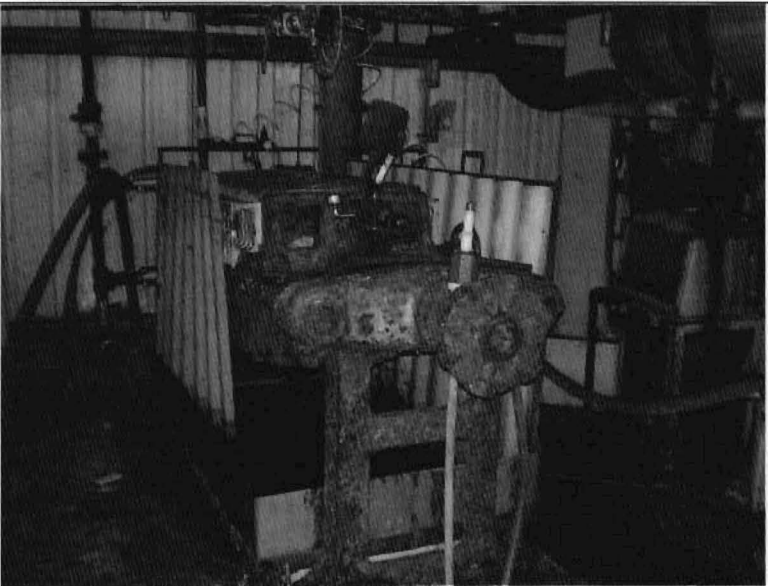
Photographer:		Les Branscum, ADEQ			Witness:		Charles Fisher, EPA	
Photo #	14	Of	16		Date:	29 JAN 08	Time:	1235
Description:		Rusted tank piping system on first floor of Production Building. Even though the water was only an inch or two deep, the damp air accelerated rusting.

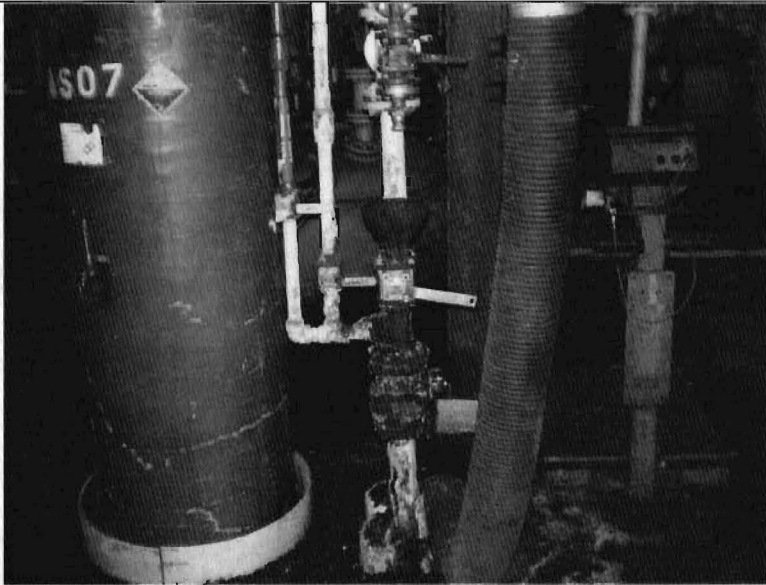
Photographer:	Les Branscum, ADEQ				Witness:	Charles Fisher, EPA	
Photo #	16	Of	16		Date:	29 JAN 08	Time: 1239
Description:	The caustic lines photographed in previous visits showing extreme degradation.
